SAN FERNANDO, CALIFORNIA,
EARTHQUAKE OF
9 FEBRUARY 1971

GORDON B. OAKESHOTT, *Editor*
CALIFORNIA DIVISION OF MINES AND GEOLOGY

BULLETIN 196
California Division of Mines and Geology
Resources Building, Sacramento, California

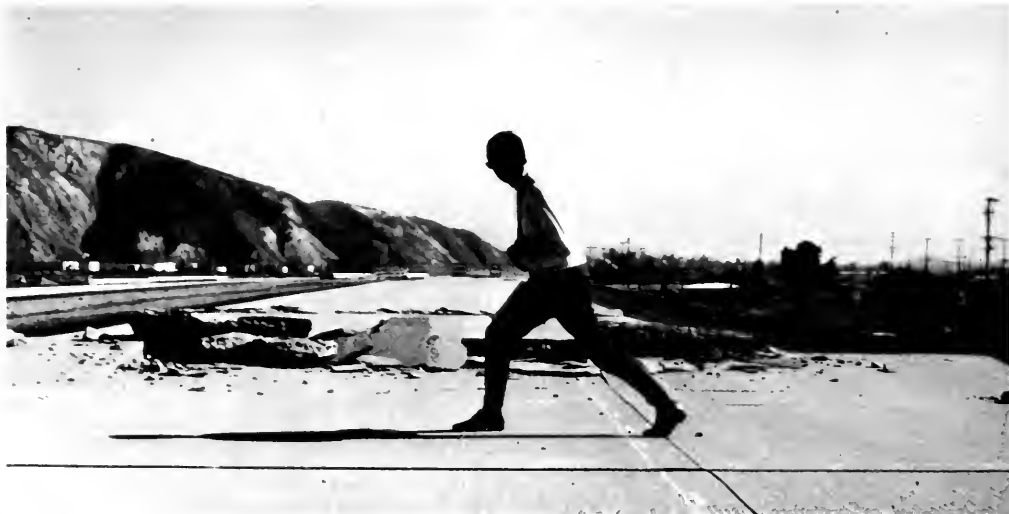
Photo 13. Dislocated roadbed, view southeast along new Freeway 210 (west lane) near Maclay Avenue. Both overthrusting and left-lateral offset occur in line with the San Fernando fault zone.

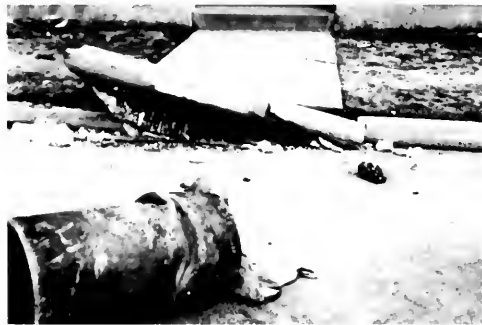
In the 1952 Kern County earthquakes, both left-lateral and reverse dip-slip motion occurred on the White Wolf fault. In the 1971 San Fernando earthquake, the San Gabriel Mountains were thrust to the south over the valley. Faulting dynamics with a substantial vertical component of slip lead to special ground response of both theoretical and practical importance. Along the San Fernando thrust fault zone, the breadth of the broken ground due to the faulting was generally greater than along much of the 1906 San Andreas transcurrent rupture. In many places an echelon fissures developed in the 1971 faulting over a 200 m wide belt. Thrusting and left-lateral offsets caused up-buckling and rotation of the ground. This vertical distortion led to particularly serious dislocations in road pavements (photo 13) with attendant increase of risk from lack of access. Tectonic compression caused severe damage to underground utility systems (photo 14).

Photo 14. Compressed section of gas pipe removed from the main line across the thrust faulting near Glenoaks Boulevard, San Fernando. Note ejected concrete curb.

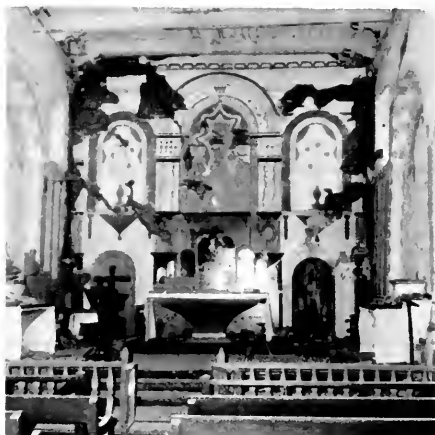
Photo 1. Photo showing damage to non-reinforced adobe walls in the interior of the chapel of San Fernanda Mission, originally built in about 1806.

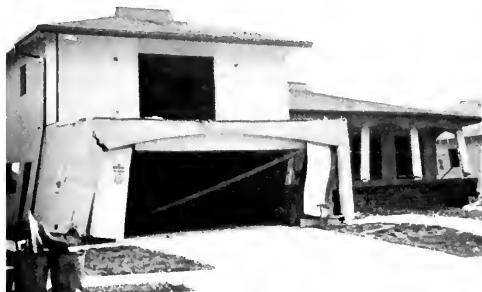
Photo 2. Severely damaged one- and two-story wood frame dwelling on Almetz Street in Sylmar District.

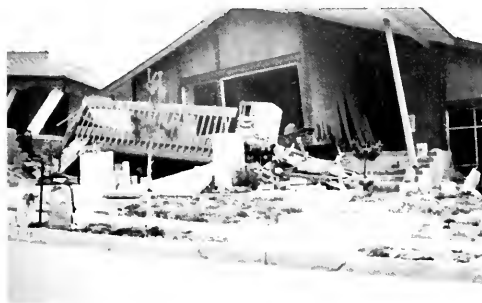
Photo 3. The upper portion of this split-level wood frame dwelling on Almetz Street has collapsed into the garage.

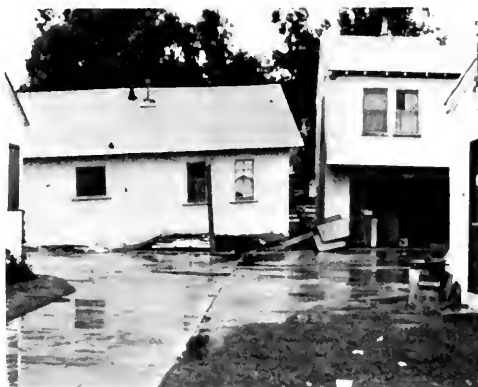
Photo 4. Wood frame structure in center was two stories high; note automobile beneath.

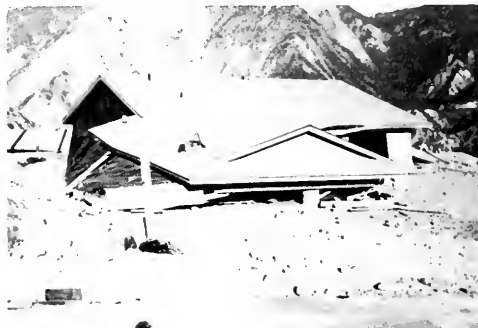
Photo 5. Collapsed dwelling in course of construction on Tucker Street near Pacoima Dam.

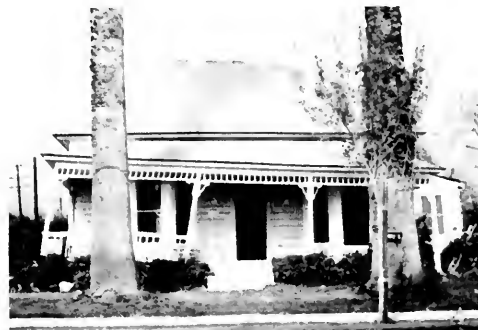
Photo 6. Older wood frame dwelling in San Fernando.

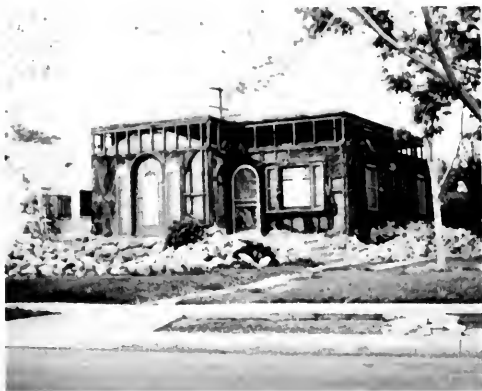
Photo 7. Older wood frame dwelling with unanchored stone veneer, in San Fernando.

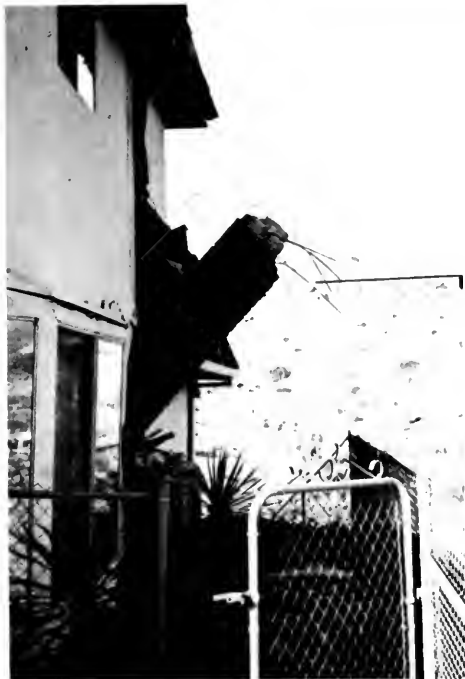
Photo 8. Damaged reinforced brick chimney in heavily damaged new district near Pacoima Dam.

Brick chimneys (listed also in table 6), before reinforcing steel was used in their construction, were damaged in even slight shocks. Had chimneys not been generally reinforced, the "none" value would have been close to zero instead of 67.6 percent. While the present standards need continued improvement, they were impressive in reducing losses.

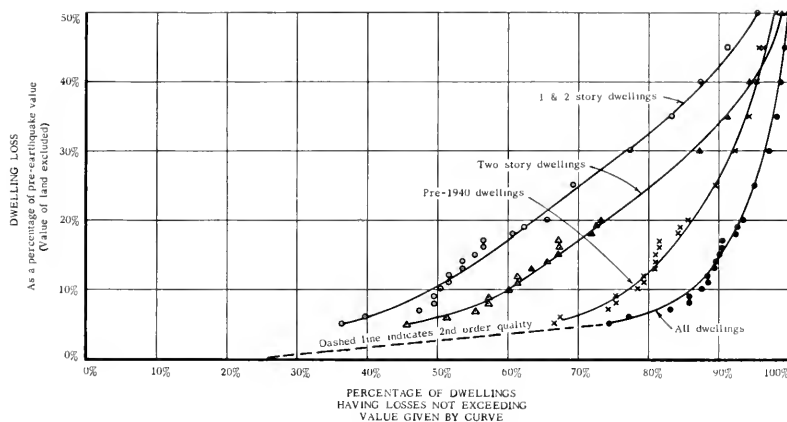
Figure 6. Percentage of loss of wood frame dwelling.

Percentage loss determinations. Figure 6 shows the results of the determination made for 12,037 inspected dwellings in the hardest hit areas contained in figure 5. The data in figure 6 do *not* include the many thousands of cases of negligible-to-very-slight damage—usually far less than 5 percent of value—found throughout much of eastern San Fernando Valley; nor does it include the extremely few cases of damage which exceeded 50 percent throughout this same area. In figure 6, the data for losses over 5 percent are of high quality but drop off quickly below 5 percent. Only the general case for losses of less than 5 percent has been plotted, and the data are of second-order quality.

Figure 6 leads to the following conclusions, provided the previously described qualifications are kept in mind:

1. About 25 percent of all of the dwellings in the hardest-hit area had losses over 5 percent. This represents 1 percent of all of the dwellings in the San Fernando Valley considered in this study; stated in a different way, about 3,200 dwelling

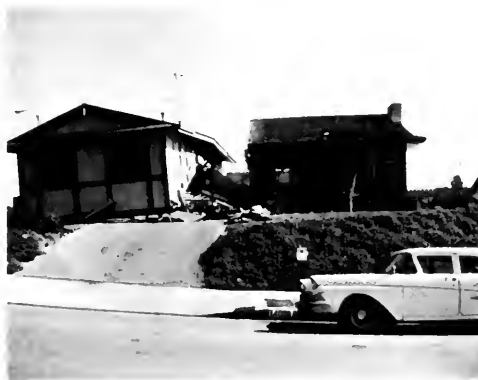
Photo 9. Left section of this dwelling was originally two stories (over garage) and attached to one-story section on right. Garage areas normally have comparatively little bracing.

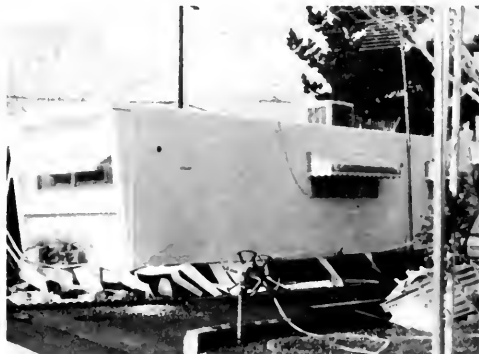
The trailers that were significantly damaged did not have the piers anchored to the ground, nor were the screwjack levelers at the top of the piers fastened to the frame of the coach. The support was structurally poor; the earthquake vividly demonstrated this. The precast-concrete pyramid-shaped piers rolled over, dropping the coach and often piercing the plywood floor. Photo 10 is an example of typical damage.

Photo 10. Mobile home shifted off its foundations; note damage to skirt. Drew P. Lawrence photo.

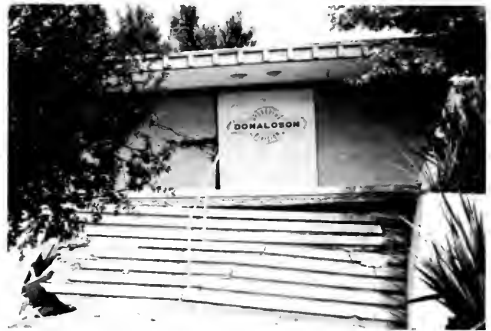
While buildings on sites where there was significant ground breakage were often badly damaged, the degree of damage resulting from soil disturbance was not necessarily in keeping with outward appearance of the building. The obvious damage to the building shown in photo 11 would, at first glance, indicate possible total loss to the structure. The badly damaged portion of the building is an entry walkway of wood frame construction. The main portion of the building, though damaged, performed reasonably well; the corner at the edge of the compression zone in the soil was only slightly affected.

Photo 11. Arroyo light industrial tract. Damage to steps due to ground movement. E. G. Zacher photo.

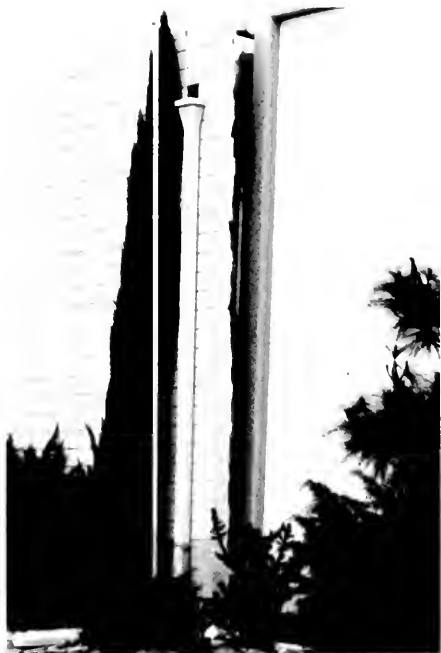
Conversely, in another case, the outward appearance of the building did not indicate how severely it was damaged. The earth movements at this location caused one structure and an adjoining one to move together so that the first building is now from 8 to 12 inches *inside* the formerly adjacent structure (photo 12). This movement, when combined with a reported 6-inch separation between buildings prior to the earthquake, indicates ground shortening and/or building movement of 24 inches or more; this is corroborated by the amount of overriding of the sidewalk in front of the building (photo 13). The resulting damage to the two structures can be seen in photo 14.

Photo 12. Arroyo light industrial tract. One building is now from 8 to 12 inches inside of the other due to ground movements. E. G. Zacher photo.

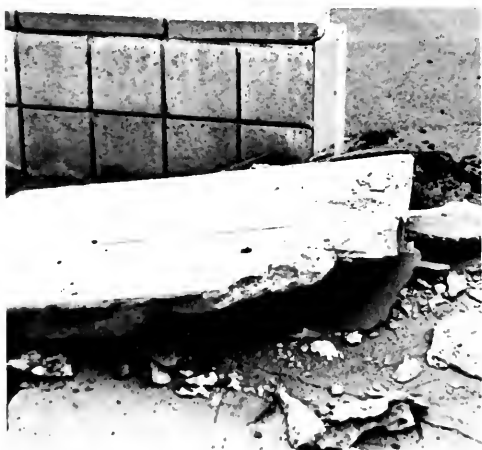
Photo 13. About 27 inches of sidewalk overriding in front of one of the buildings shown in photo 12 indicates the local extent of ground surface shortening. E. G. Zacher photo.

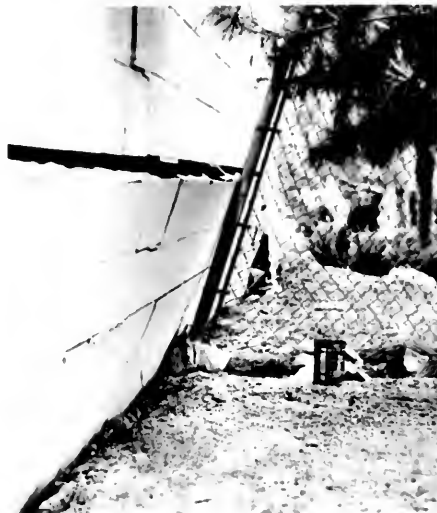
Photo 14. Damage due to ground surface shortening in the Arroyo light industrial tract. E. G. Zacher photo.

Unfortunately, the type of damage directly or indirectly due to ground displacements cannot be overcome by existing earthquake-resistive design-and-construction practices, nor is it practical to do so. However, site-planning can and must avoid geologically hazardous locations as far as the state of the art allows.

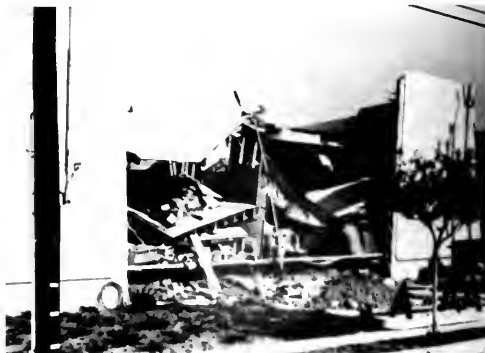
The remaining structures in the Arroyo tract were not known to have been subjected to severe ground displacement. The only reinforced-concrete tilt-up wall building in this tract to have a wall panel collapse was not on a site having visible *major* ground displacement, although the building lengthened about 6 inches in a north-south direction. The severe damage that was

sustained by this structure, photo 15, must be attributed partially to questionable construction details for both tilt-up-wall and diaphragm connections (photo 16) as well as to the increase in building length.

Photo 15. Tilt-up wall panel failed, bringing down portions of the roof and mezzanine floor. Arroyo light industrial tract. See also photo 16. John Meehon photo.

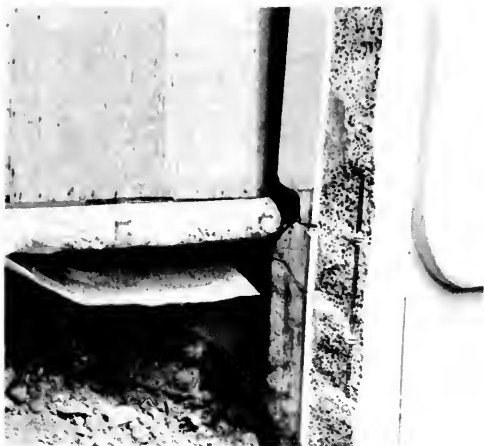
Photo 16. This is a detail of photo 15. Drilled expansion bolts from floor slab (shown) to tilt-up walls failed to hold panel in place. Similar failures occurred where the 3-inch dowels from the tilt-up wall to the pilaster proved to be completely inadequate. E. G. Zacher photo.

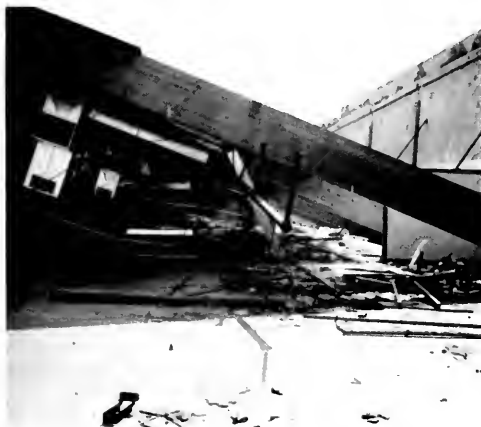
More than half of the buildings in the Bradley tract had portions of their roofs collapse; see, for an example, photo 17. Only three buildings had partial wall collapse; see, for an example, photo 18. A large number of buildings sustained damage at the roof-beam (or girder)-to-wall connections. These connection failures were noted where portions of roofs collapsed (photo 19) or where collapse did not occur but was incipient. The partially collapsed roofs which exerted lateral

Photo 17. Collapsed roof, Bradley light industrial tract.

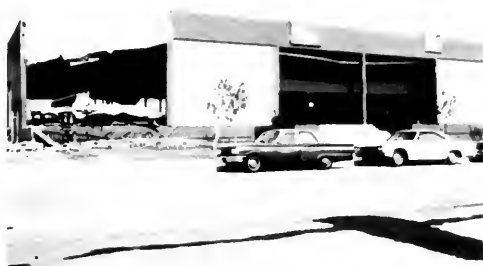
Photo 18. One of three structures in the Bradley light industrial tract that had one or more sections of its walls fail.

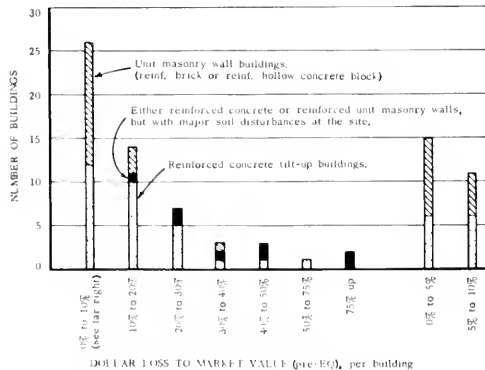
Figure 7. Loss distribution by wall type for light industrial construction.

Figure 7 shows the loss distribution by type of wall construction. Clearly, almost half of the buildings examined had less than 10 percent loss; the right side of figure 7 shows losses under 5 percent to be common.

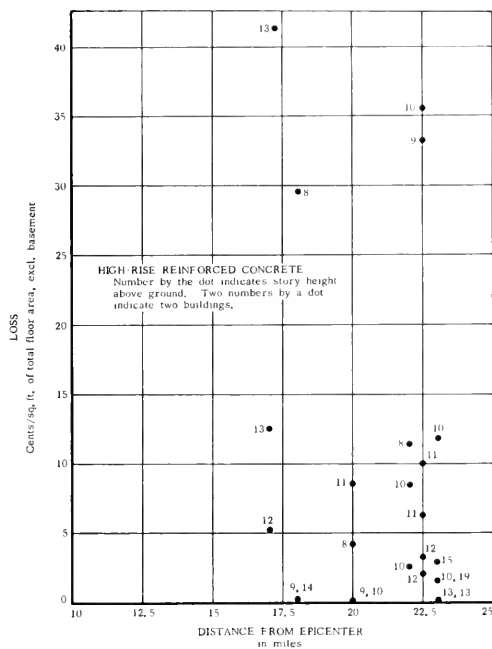
Figure 8. Losses to earthquake resistive high-rise reinforced concrete buildings.

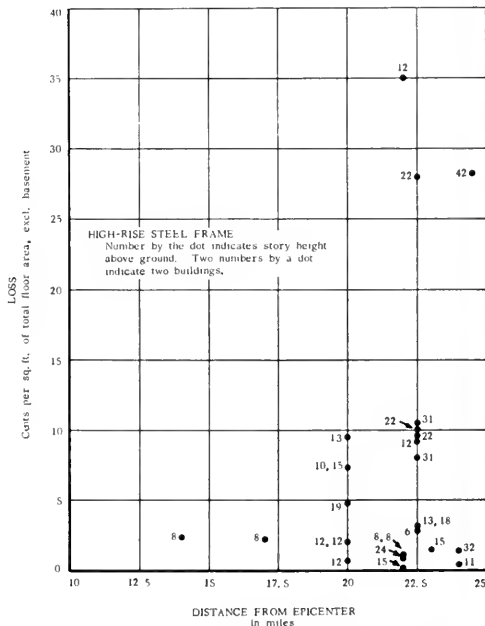
Figure 10 is a compilation of reported losses to 30 completed steel-frame buildings, 6 to 42 stories in height, all in the general vicinity of the concrete structures (figure 9).

Figure 10. Losses to earthquake resistant high-rise steel frame buildings.

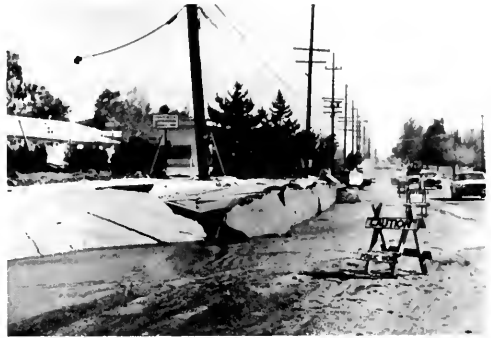
Nursing homes were also damaged. Most interesting among these is the Foothill Nursing Home where surface faulting traversed the site (photo 20), lifting the structure about 3 feet above the street in front of it. This one-story reinforced hollow-concrete-block structure was unoccupied and unused at the time of the earthquake. Although racked by vibration and permanent ground displacements beneath it, the building did not collapse. Its earthquake performance under these conditions was comparatively excellent—certainly the life-safety hazard was substantially less than that at some buildings at the Olive View and Veterans Administration Hospitals.

Photo 20. Foothill Nursing Home on Foothill Boulevard, Los Angeles. Sidewalk has been raised 3 feet by faulting with respect to the street. The Ledger (La Cañada Valley) photo.

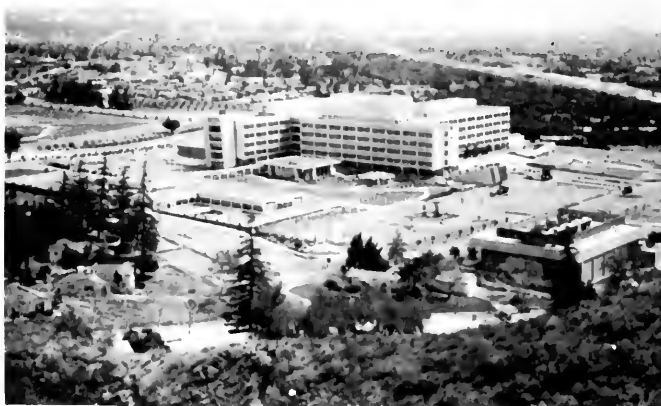
Photo 21. Olive View Hospital. Central Heating and Air Conditioning Building, lower right; Medical Treatment and Care Facilities; center, Psychiatric Unit, center left.

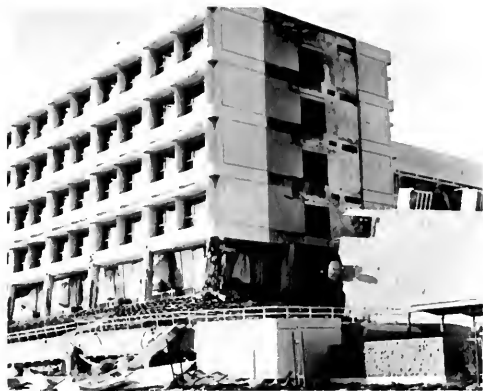
Medical Treatment and Care Building—earthquake damage. Earthquake damage was excessive in the first story and basement, with little damage above the first story. This abrupt change in rigidity at the second-floor level undoubtedly contributed to the severe damage at the first-story level. The building was leaning as much as 2 feet in a northerly direction after the shock, with essentially all of this permanent offset (story drift) in the first story. The first story nearly collapsed.

Photo 22. Medical Treatment Building, toward the southeast corner. Note overturned stair tower at right, broken columns, and collapsed ground story under landscaping. Los Angeles County Fire Department photo.

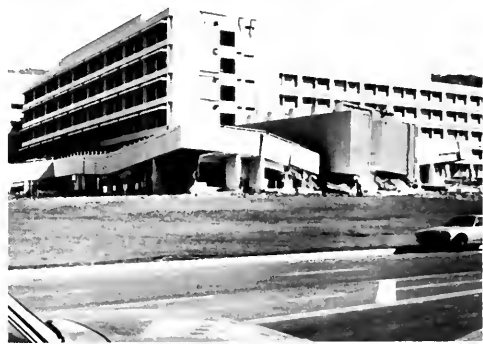
Photo 23. Medical Treatment Building, looking at southwest corner. South stair tower overturned and collapsed on one-story portion; roof at stair tower is center right. Los Angeles City Fire Department photo.

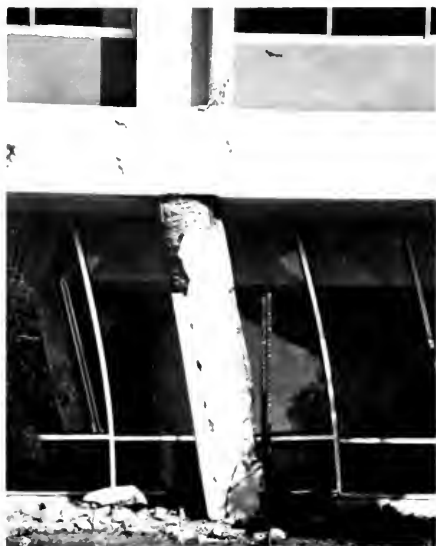
Photos 21 through 34 show views of the exterior elevations and some of the detailed damage. The spirally wrapped reinforced-concrete columns (photo 24) performed much better than the tied columns (photo 25). Certainly there was a substantial reserve of strength in the spirally wrapped columns, or the building would have collapsed, as it was so far out of plumb. Some steel reinforcing bars in columns were broken; where the bars were fractured, the fractures were near, but not in, the welds (photo 26). Precast-concrete wall panels failed when portions of the building collapsed (photo 27). While nonstructural

Photo 24. Spirally wrapped reinforced concrete column; compare with tied column (photo 25). Note distorted mullions for glass and about 2-foot offset in first story.

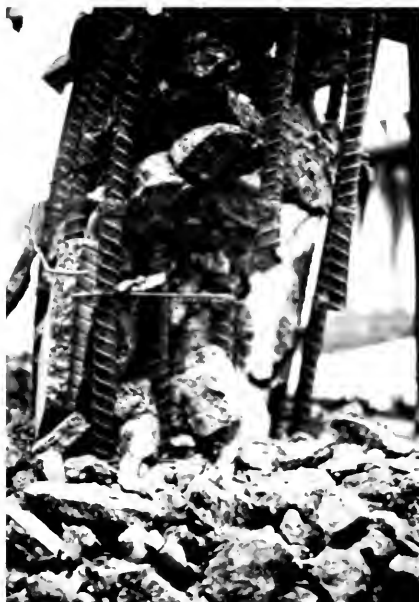
Photo 26. Some vertical reinforcing steel in tied columns broke, usually near the weld splicing bars as shown here.

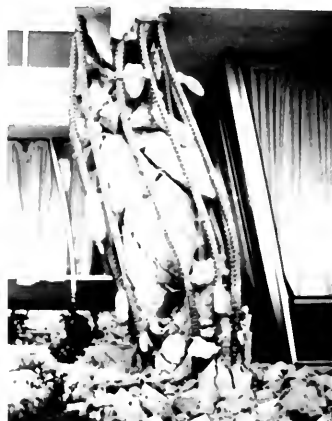
Photo 25. Tied reinforced concrete column having little remaining strength. Ties broke, and the vertical steel broke as shown in photo 26.

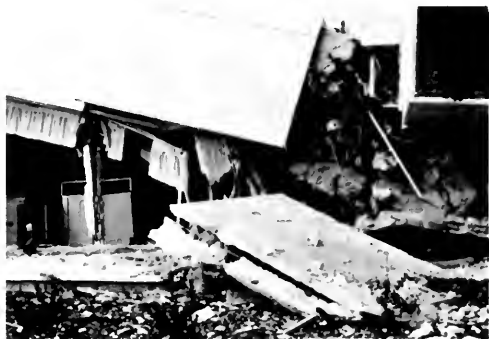
precast-concrete facings should not be expected to be intact after the building begins to collapse, it is not unreasonable to hope for shattered panels which do not leave their backing walls.

Photo 27. Precast concrete wall panel on ground fell from supporting structure at emergency entrance (basement level).

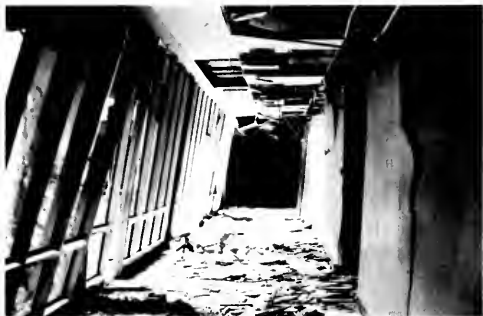
Damage to first-story ceiling tile (photo 28), elevator doors (photo 29), telephone equipment in the basement (photo 30), and other features was excessive.

Photo 28. Fallen ceiling tile, first story of Medical Treatment Building. Glass was originally vertical.

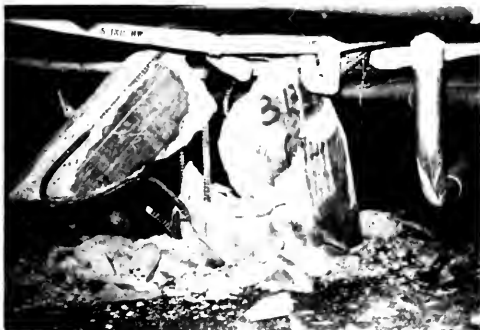
At least some columns in the basement areas apparently failed due principally to excessive *vertical* forces. Photo 31 shows basement-column failure on the south elevation; there was no significant evidence of horizontal forces sufficient to cause this damage.

Photo 31. Shear failure of reinforced concrete column in ground story.

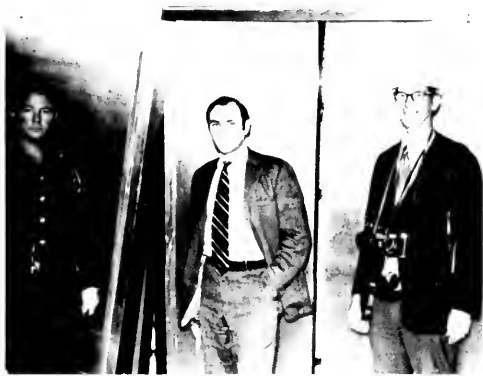
Photo 29. Inspectors at jammed elevator doors, first story of Medical Treatment Building.

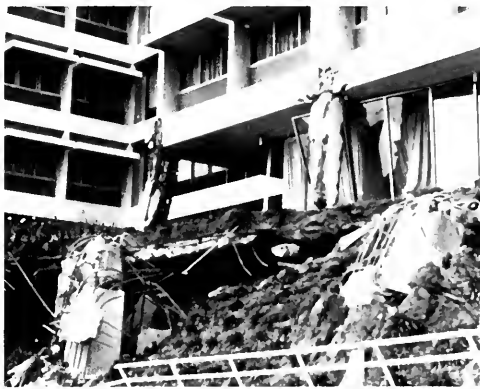
Photo 32 shows the failure of an interior basement-column below landscaping. These, and many other basement-column failures, strongly indicated an excessively high level of vertical earthquake forces.

Photo 32. Column punched through the roof slab supporting a landscaped area at the first floor level.

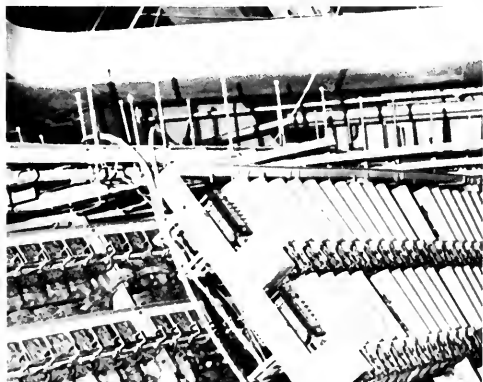
Photo 30. Telephone equipment damage, basement of Medical Treatment Building. John Meehan photo.

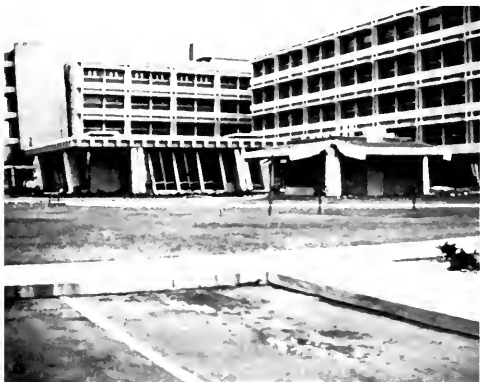
The four stair towers were of reinforced-concrete construction. Three towers which were supported by tied reinforced-concrete columns overturned, while one on its own footing leaned to the north (photo 33). It is important to note that the failures were due

Photo 33. Note partially overturned stair tower at left. Fume Exhaust Building in center right had broken cantilevers (photo 43).

to overturning and not to shear. The failure of three towers and partial failure of one tower, all containing stairs intended for evacuation, made them unusable after the shock.

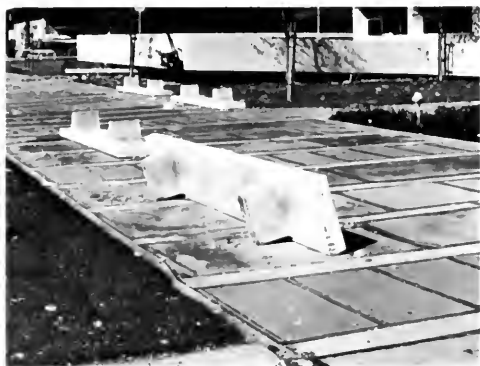
Photo 34, shows four overturned concrete benches, each of which is too heavy for a person to turn over. The concrete-covered walkway in the background leaned as shown after the shock.

Photo 34. Overturned concrete benches north of the Medical Treatment Building.

The foregoing are consistent with very heavy horizontal ground shaking on soft soil. This is partially confirmed by the several overturned concrete benches (photo 34); roughly made calculations suggest earthquake forces of two-thirds (67%) of gravity. This is well over code-required forces; this subject is more thoroughly discussed in the section on earthquake forces. Vertical acceleration was also excessively high as evidenced by failed cantilever beams and by some broken basement columns.

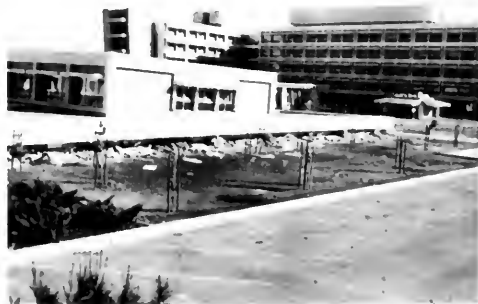
Cause of the collapse was ground motion, both vertical and horizontal, which induced stresses in the lateral-force-resisting elements beyond their ultimate capacity. Specifically, the first-story columns failed, dropping the second floor onto the first floor (photo 35). The second floor also was translated toward the south and east, rotating slightly counter-clockwise when viewed from above. The center of rotation was somewhere near the northeast corner. Photo 36 shows the remains of a reinforced-concrete column.

Photo 35. Psychiatric Unit, of which the first story collapsed. Los Angeles County Fire Department photo.

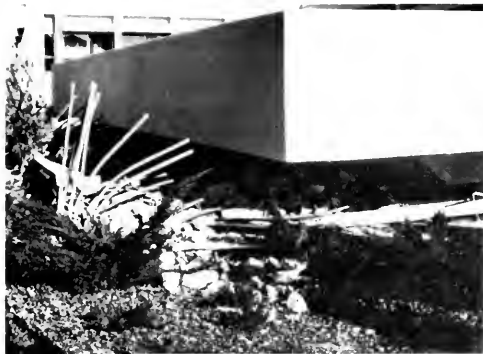
Photo 36. Psychiatric Unit, with first story roof now on the ground. Dowels (reinforcing steel from footing) show that building moved laterally during failure.

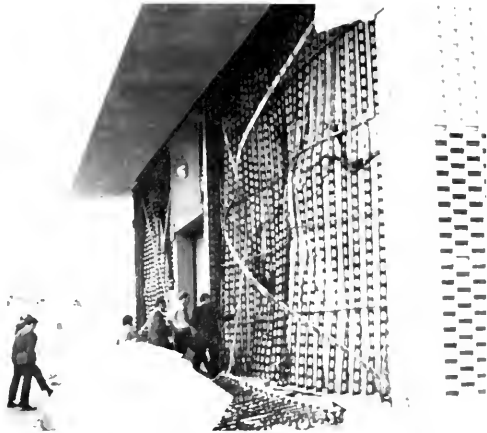
Photo 37. Rear of Central Heating and Air Conditioning Building.

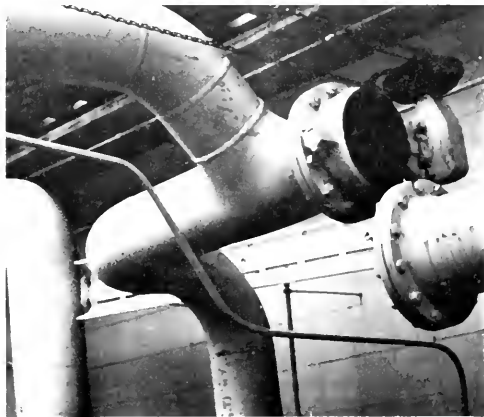
Boilers shifted as much as 4 feet and caused a small fire. Photos 38 and 39 show the damage to piping and other equipment. Possibly the most important lesson, however, comes from the failure of unanchored and poorly anchored equipment required for standby power. Photo 40 shows the failure of unanchored batteries required for activating this standby power, and photo 41 shows the damage to the emergency generator. It is mandatory that standby power equipment, as well as emergency communications equipment, be strongly and very conservatively braced. Bracing of this type of equipment is too often neglected by all concerned.

Photo 38. Broken piping, Central Heating and Air Conditioning Building.

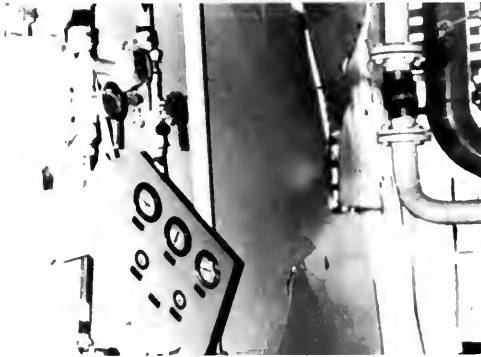
Photo 39. Equipment damage, Central Heating and Air Conditioning Building, John Meehan photo.

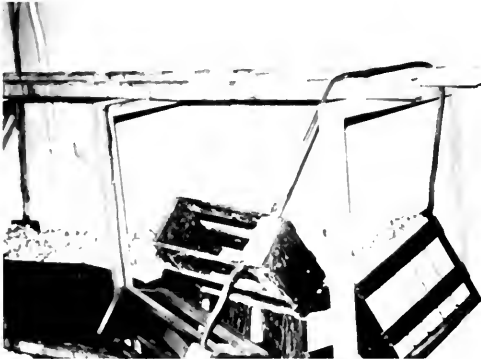
Photo 40. Fallen unchored batteries required for activating standby power operation.

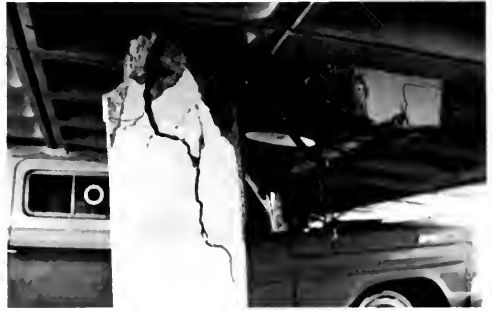
other new structures. Photo 42 shows the seriously damaged ambulance carport south of the Medical Building; there was evidence of high vertical acceleration. The Assembly Building was also badly damaged and leaning to the north. Photo 43 shows the typical serious cracking of the roof cantilevers of the Fume Exhaust Building north of the Medical Building, again explainable by high vertical acceleration.

Photo 42. Carport collapsed on several ambulances.

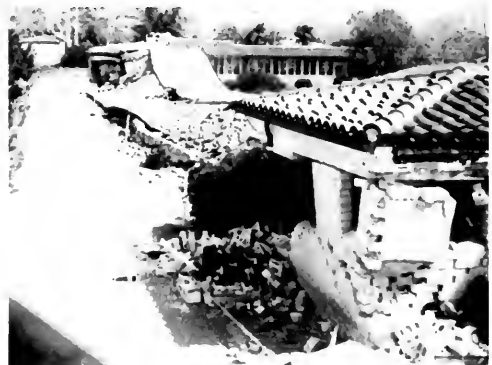
Much older construction elsewhere on this hospital site also was heavily damaged. Photo 44 shows the collapse of an unreinforced hollow-concrete-block building. Old wood-frame structures typically fell when their unbraced cripple-studs gave way (photo 45); this type of damage very rarely leads to loss of life.

Photo 44. Collapsed unreinforced hollow concrete block building at Olive View Hospital.

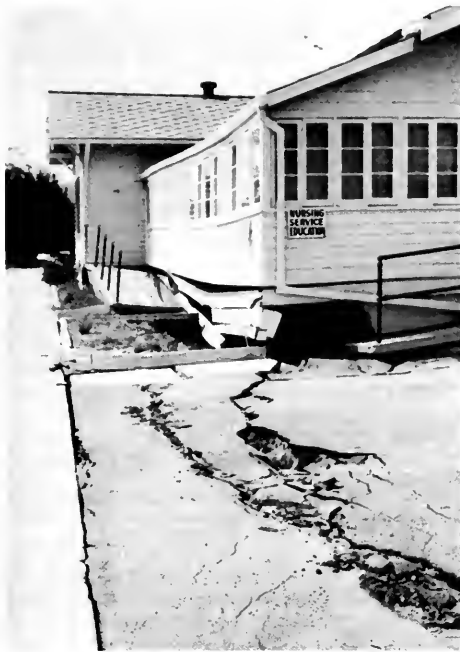
Photo 45. Damage to old wood frame structures of Olive View Hospital.

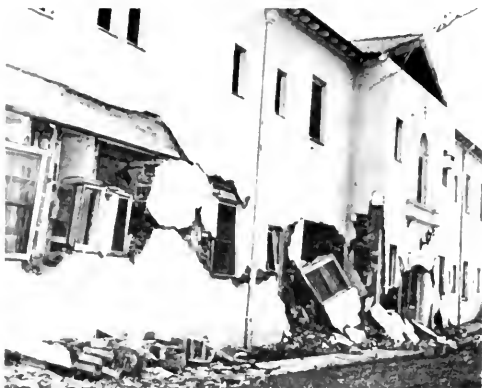
Photo 47. Partially collapsed building having hollow clay tile filler walls, Veterans Administration Hospital. Los Angeles County Fire Department photo.

in the entire earthquake. Some damage details and rescue operations may be seen in photos 47 and 48.

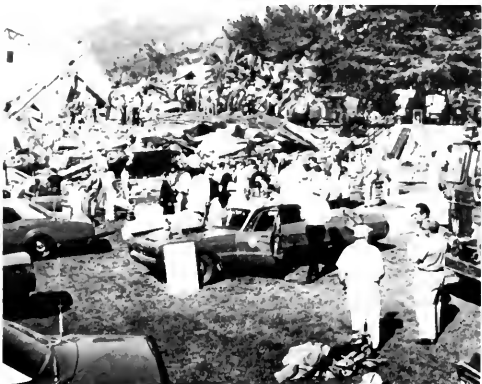
Photo 48. Rescue operations, Veterans Administration Hospital. Los Angeles City Fire Department photo.

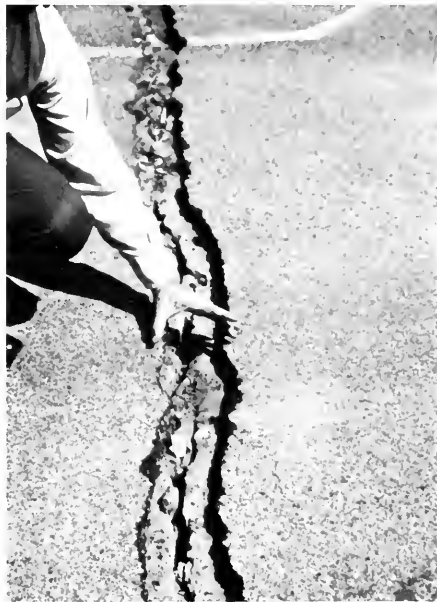
While the locations of pipeline damage and building damage were in good agreement, observable *permanent* ground differential displacements outside of the faulted areas were not so clearly related and were few in number. Asphalt pavement cracks were common, and shifted concrete sidewalks (and sidewalk cracking) were common. However, in the case of cracks in asphalt pavement, the width of the pavement crack was substantially greater than the width of the ground crack (if any) below the pavement crack; photo 49 is one such example. This suggests that the violent ground motions left more visible evi-

Photo 49. Asphalt paving cracks were almost invariably much wider than the soil cracks.

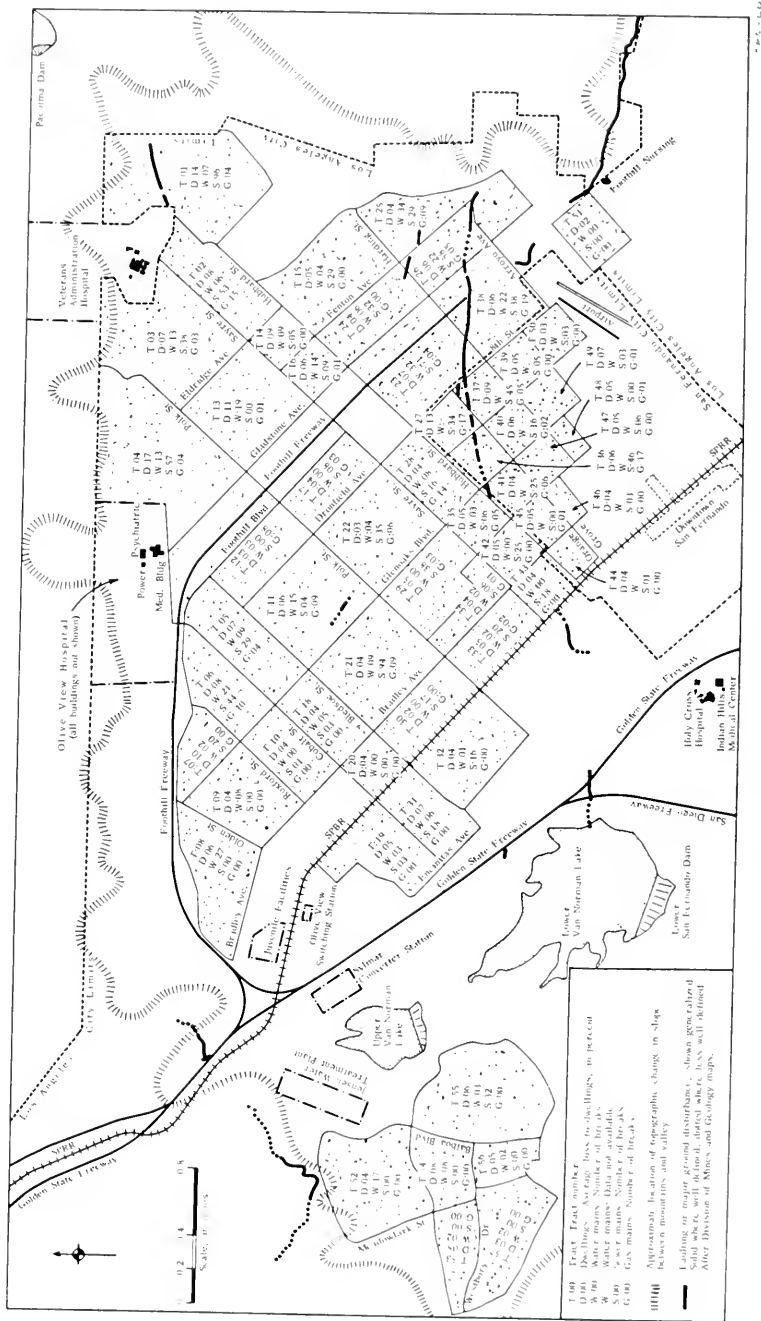
sistencies, the evidence strongly indicates that damage to the underground water, gas, and sewage mains correlated well with building damage.

Figure 12. Distribution of damage to dwellings and to water, gas, and sewer mains.

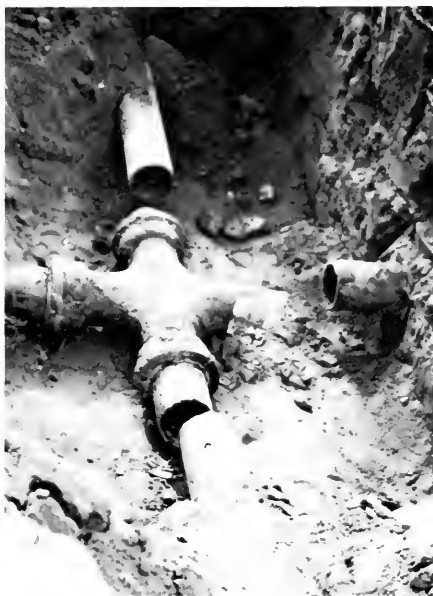
dences in the asphalt pavements which were more rigid, and probably much stronger, than their supporting soils. It appears that the underground-pipeline failures followed a pattern similar to the asphalt-paving breakage. Photos 50 and 51 are examples of pipeline damage which is closely related to fault movement in these instances.

Photo 50. Typical view of water pipe joint separations and shears near joints.

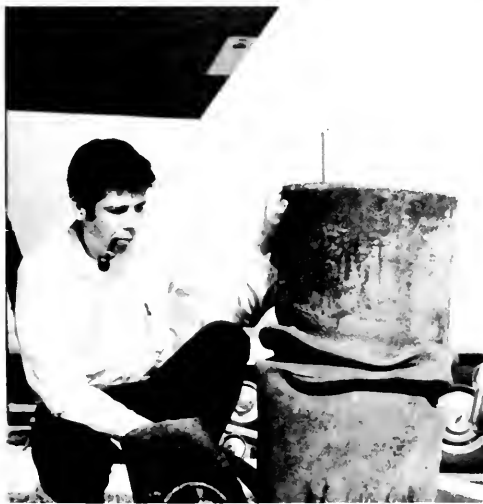
Photo 51. Compressive forces buckled 16" steel gas pipe in Glonaaks Boulevard, San Fernando. Southern California Gas Co. photo.

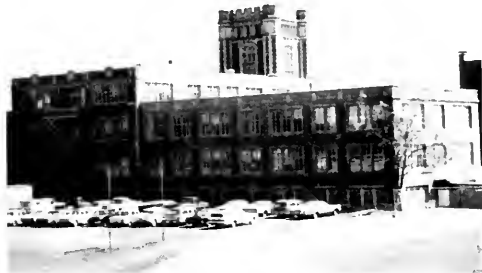
Los Angeles High School is more than 20 miles from the Pacoima Dam. (1) The main building (photo 1) on this high school site was a pre-Field-Act building constructed in 1917, contained about 200,000 square feet of floor area and was constructed of wood floors, concrete frames, unreinforced brick masonry exterior walls, unreinforced hollow clay tile interior partitions. Masonry was laid in lime mortar. The building was supported by spread footings. Two long sections of the parapet and adjacent brick veneer fell off one portion (photo 2). Portions of the debris fell through the lower wood roof to the floor below (photo 2). Other portions fell on the exit stairway and into the court yard area (photo 3). The exterior

Photo 1. Los Angeles High School. Parapet and veneer shaken off four-story portion of this pre-Field Act school building.

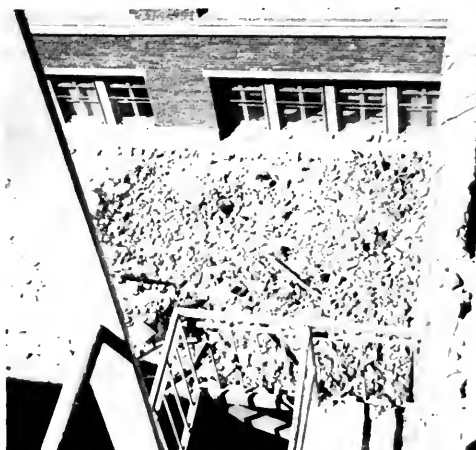
Photo 3. Los Angeles High School. Parapet debris in school yard.

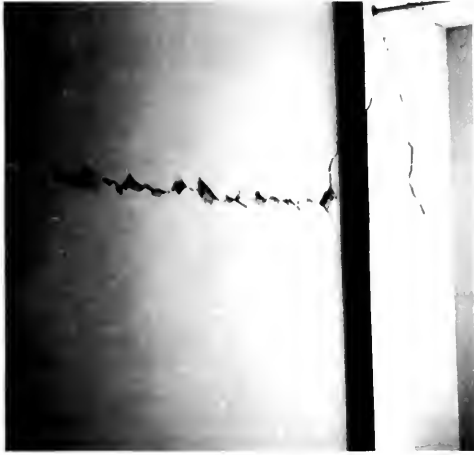
Photo 4. Los Angeles High School. Interior-partition damage at stairway.

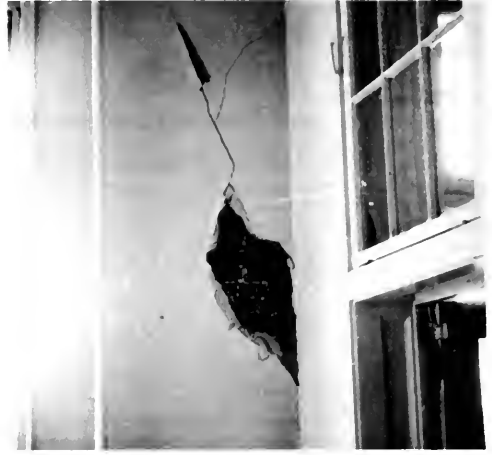
Photo 5. Los Angeles High School. Brick and wall damage at exit door.

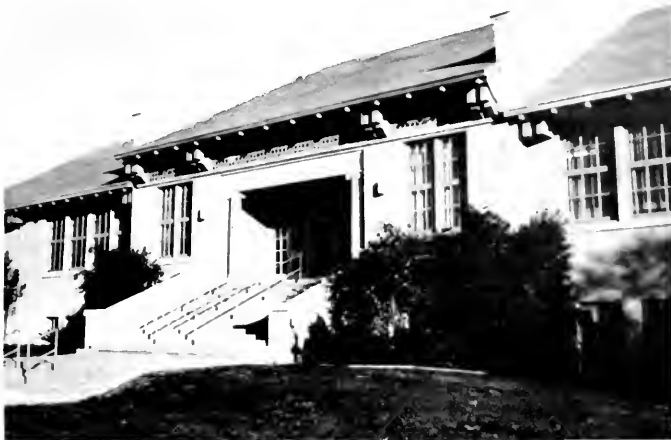
Morningside Elementary School (2) is about 4 miles from Pacoima Dam and is comprised of both pre-Field-Act buildings and post-Field-Act buildings. One pre-Field-Act building constructed in 1917 was rehabilitated in 1964 to meet the requirements of the Field Act (photo 6). This building sustained damage amounting to cracks in the old and new walls; several roof anchors pulled loose; plaster was damaged throughout the building; and light fixtures fell. The

Photo 6. Morningside Elementary School. Rehabilitated to meet the requirements of the Field Act.

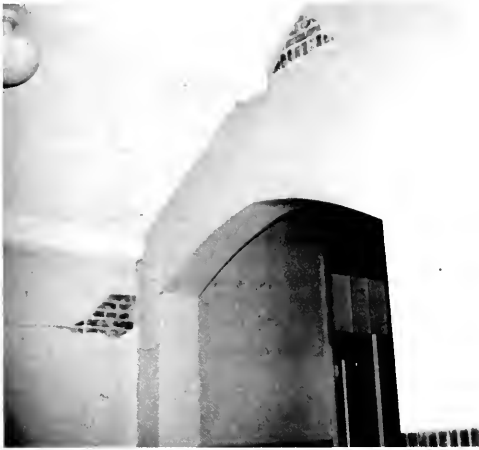
The other pre-Field-Act building had not been rehabilitated. Masonry walls throughout the building were extensively damaged (photo 7). The parapets were on the verge of falling (photo 8). Light fixtures fell or were displaced. The cost to demolish this 13,000-square-foot building is estimated at about \$13,000, and the estimated cost to replace it is about \$442,000. The present value of the buildings and site improvements amounts to about \$1.4 million.

Photo 7. Morningside Elementary School. Unrehabilitated pre-Field Act building. Typical interior-wall damage.

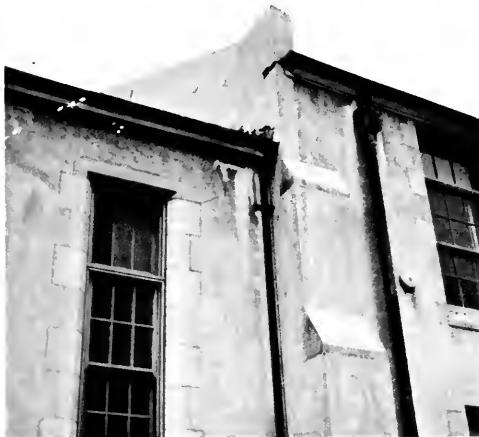
Photo 8. Morningside Elementary School. Pre-Field Act building. Parapet on verge of falling.

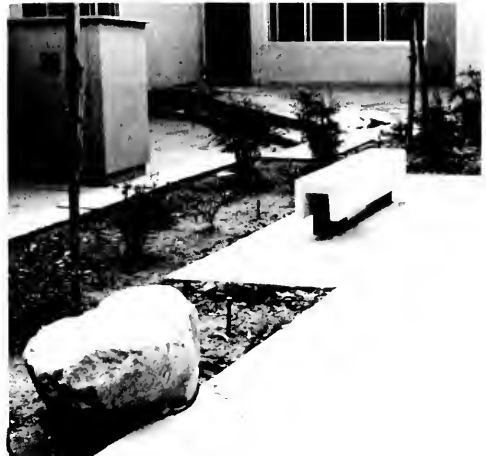
Van Gogh Elementary School (3) is about 6¼ miles from the Pacoima Dam. This school was constructed in 1968 under the provisions of the Field Act. There was extensive ground cracking throughout the site and building (photo 9). Shortly after the earthquake, it was reported that the site would be abandoned; however, the site was examined geologically and the buildings were investigated structurally, resulting in the decision to repair the site and buildings and continue their use. The site is on the flank of a

Photo 9. Van Gogh Street Elementary School. Diagonal crack in slab near rock; damage in the concrete steps beyond.

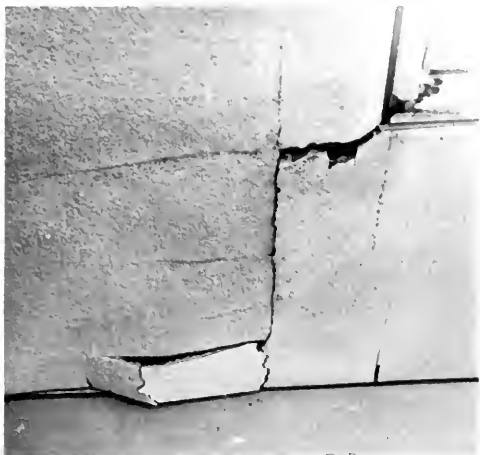
rather broad alluvial fan, and it is believed the ground displacement was due to liquefaction. Depth of the alluvium is unknown but exceeds 35 feet. The building, which is supported on several feet of recompact soil or engineered fill, is wood frame supported by spread footings. Ground cracking caused the foundations and slabs on grade to crack (photo 10), as well as the walls and roof (photo 11).

Photo 11. Van Gogh Street Elementary School. Underside of roof overhang damaged above ground cracks.

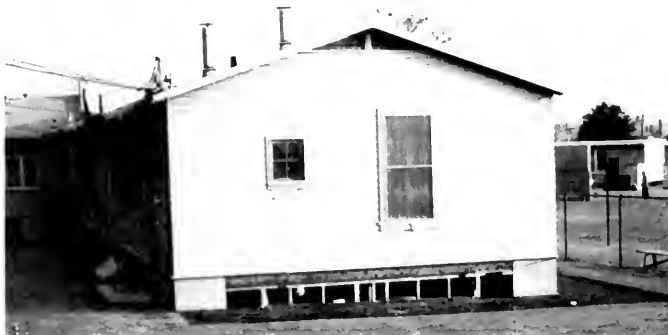
Photo 12. Hubbard Street Elementary School. Repairs being made to underpinning of a bungalow.

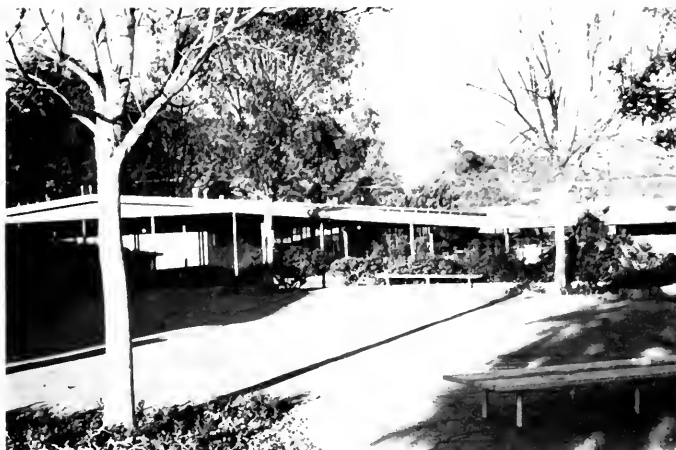
Photo 13. Fenton Avenue Elementary School. Essentially no damage.

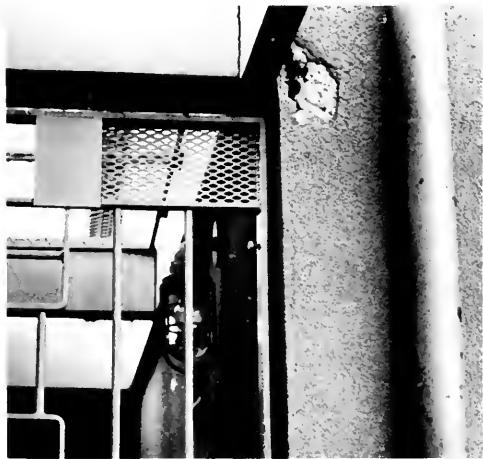
Photo 14. Fenton Avenue Elementary School. Slight damage to stucco where lunch-shelter roof joined multipurpose building.

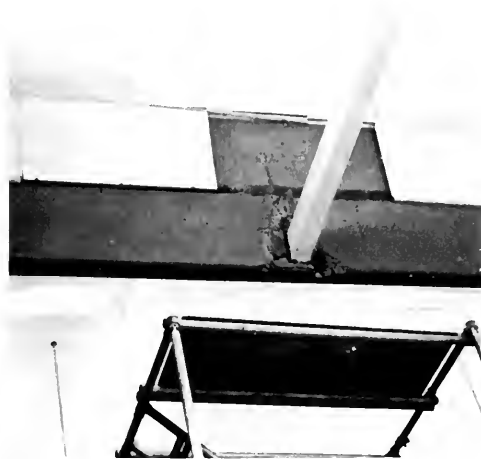
nasium which is a prestressed concrete folded-plate roof, with walls of reinforced concrete, resting on concrete piles. The gymnasium floor had some settlement and two roof beams were spalled a bit at a cross beam used to support gymnastic equipment (photo 15). This cross beam was added after the building was built and not installed under Field Act provisions. No damage could be found to the gymnasium piles.

Photo 15. Sylmar High School Gymnasium. Damage to prestressed concrete beam at gymnastic equipment cross beam.

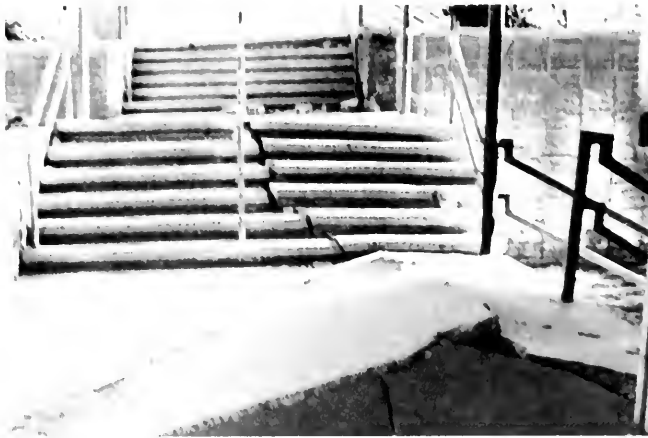
There was considerable damage due to ground breakage. Many sidewalks and slabs on grade were broken throughout the site (photo 16). Equipment

Photo 16. Sylmar High School. The site had considerable ground fissures.

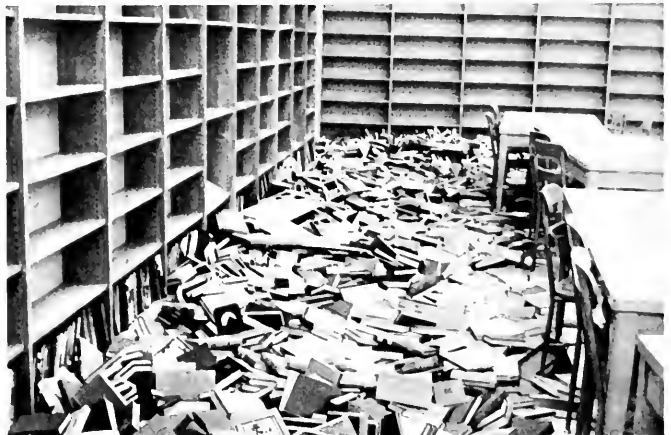
was thrown about; light fixtures fell to the floor in several rooms; plaster was cracked and fell; and arcades pounded together at the joints and library books were thrown from the shelves (photo 17). A large retaining wall rotated about 8 inches. A flag pole bent at the first lower welded point (photo 18), and a flood-light pole bent at the upper welded joint. This site sustained the greatest amount of damage which was primarily due to the ground cracking and displacement, of any post-Field-Act construction. The estimated cost for the repairs to the building and site was about \$485,000; the cost for debris removal was

Photo 17. Sylmar High School. Library books thrown off shelves. Note uniform depth of books.

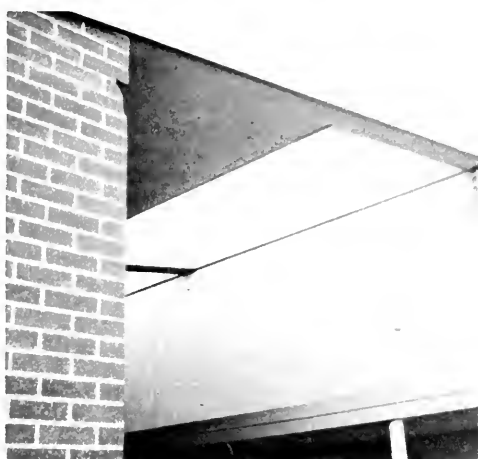
steel; the exterior was of reinforced, grouted, brick masonry. The site contained some ground cracks (photo 19). Light cracking occurred at the corners of the reinforced, grouted, brick-masonry walls where steel beams were anchored to these walls (photo 20). When repairs were made to these beam-wall connections, it was noted that the construction details did not conform to the details shown on the plans; that is, certain welds and anchor bolt ties were omitted. Ceiling and light fixtures became unraveled (photo 21). There are five schools in this school district. All school buildings are post-Field-Act construction, and the total contractual cost for the repair of damage in this district amounted to \$42,212.

Photo 20. Soledad Canyon Elementary School. Damage in reinforced grouted brick masonry wall below roof beam at left.
